# Root Caused Failure Analysis Deodorizer Column at Expansion Bellow and Vacuum Chamber Connection to Column in Refinery Plant

Muhammad Adyutatama<sup>1,2\*</sup>, Hadi Sutanto<sup>3</sup>

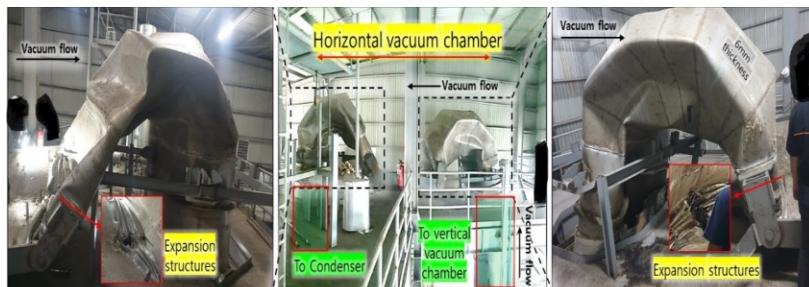
**Figure 2.**

The failures result in the complete collapse of the condenser-to-deodorizer vacuum chamber. Subsequently, we attempted to locate the specific regions of failure within the whole vacuum chambers. The regions of failure included the expansion structures, tears in the weld joints of the curved structures (between the horizontal and vertical vacuum chamber), and tears in the weld joints of the vertical vacuum chamber. Figure 2 illustrates the occurrence of collapsed structures at the horizontal vacuum chamber, which connected the ice-condenser on the left side to the vertical vacuum chamber on the right side. The whole structures were compressed, indicating their inability to sustain

the vacuum pressure at that moment. Moreover, the investigation extended to the regions where failures occurred in the expansion structures. The failures indicated that plastic deformation had taken place on both the right and left sides of the expansion structures. The welded joints on the expansion structures remained intact, suggesting that the failures were not related with the joint in the expansion structure. In order to determine the cause of the failures, samples of the expansion structures were gathered and examined using scanning electron microscopy (SEM).

The Failures of Expansion Structures at Horizontal Vacuum Chamber

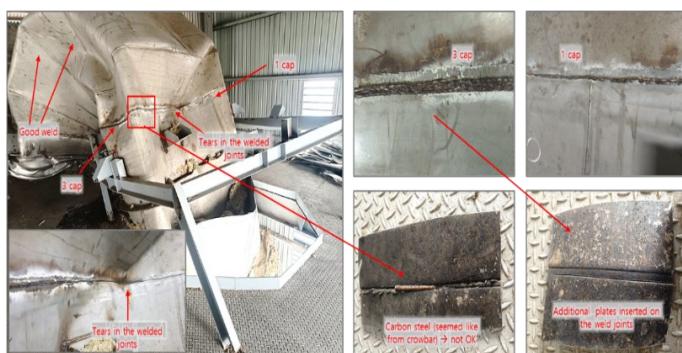
**Figure 3.**

The Failures at Horizontal Vacuum Chamber (cont.)

Additional unusual observations were noticed on the welded joints that were welded on-site. These included the presence of an uneven pattern of welding reinforcements on the joint surface, namely a 1-cap (or 1 welding line) and a 3-cap (3 welding line) as seen in Figure 3. The failures happened in the 1-cap welding line. According to this evidence, it has been verified that the tears in the welded joints originated from the low tensile properties of the 1-cap welding line, rather than the 3-cap welding line. Furthermore, these unusual welding reinforcements (1-cap and 3-cap) originated from the different weld joint designs. Two chamber plates were welded using 1-cap welding reinforcement. Alternatively, a 3-cap welding reinforcement involved the welding of two chamber plates with a third plate sandwiched in between. The findings indicated that the welders implemented additional precautions, perhaps in response to mitigating the significant distortion that occurs during the welding process. Unfortunately, those actions had an impact on the variation in mechanical characteristics along the welding line. During the operation, when the loading occurs in this welded line, the stress tolerance of the welding line varies. In this circumstance, the 1-cap welding line is more prone to failure, and it confirmed by the failure location.

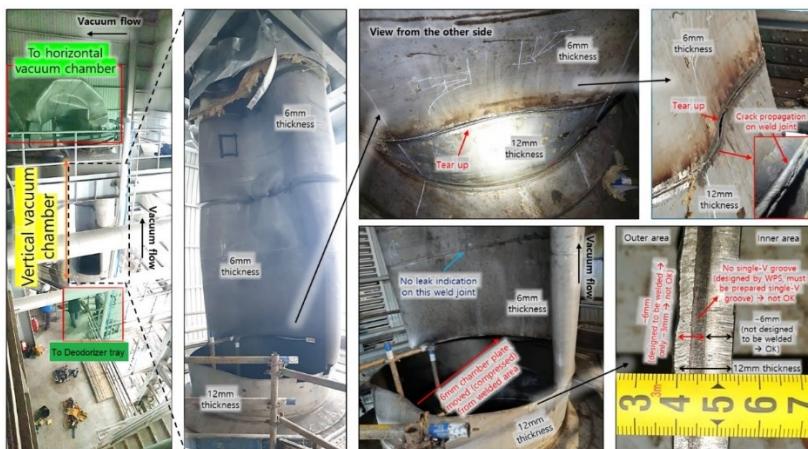
A vertical vacuum chamber serves as a conduit that connects the horizontal vacuum chamber to the deodorizer tray. As illustrated in Figure 4, failures predominantly occurred at the weld joints which connecting the 6mm thick plate to the 12 mm thick chamber plate. This type of failure mirrors the defects observed at the curved section of the horizontal vacuum chamber, where the weld joints were completed on-site. Upon closer inspection at higher magnification, tears in the welded joints were evident, along with the propagation of cracks originating from the weld region. Despite these observations, no signs of leakage were detected in either the 6mm or 12 mm thick material. The failures further suggest that the 6mm thick chamber plate experiences movement and compression against the adjacent plate following the weldment failure.

**Figure 4.**  
The Failures at Vertical Vacuum Chamber

The fracture surface analysis of the failed welded joints, with thicknesses of 6mm and 12 mm, revealed that improper welding techniques were employed throughout the process. Initially, the welding penetration depth was limited to approximately 2-3 mm, whereas the welding process specification (WPS) document prescribed a penetration depth of 6mm. Additionally, the presence of a 3mm flat section, resulting from the 6mm thick chamber plate, indicates that the single-V groove specified in the WPS document was not adequately formed during the welding preparation process. These observations

suggest that it was challenging for the welders to achieve complete joint penetration at the time. Furthermore, the criteria for pressure vessel applications, as outlined in the American Society of Mechanical Engineers (ASME) Section IX code, are insufficient for cases of partial penetration. These criteria include the use of radiography (QW-191.1.2) and ultrasonic tests (QW-191.2.2) (American Society of Mechanical Engineers, 2023). However, the on-site inspection of the welding was limited to a dye-penetrant test, which only detects surface crack indications. Similar to the horizontal vacuum chamber section, a black deposit is found inside the vacuum chamber. No significant general thinning was found at the external side and also no significant thinning found from the failure area near the welding.

- Follow the welding procedure specification (WPS) document.
- Inspect the preparation of the welding process to ensure that the single-V groove is being prepared appropriately.
- Inspect the weld during and/or after the welding process to ensure that it has achieved complete joint penetration.
- Employ another non-destructive testing method, such as radiography, to verify the completeness of the joint penetration.
- Reduce non planned start and stop / loading and unloading operation which could lead to cyclic stress which trigger the fatigue damage mechanism in the critical part of the equipment.

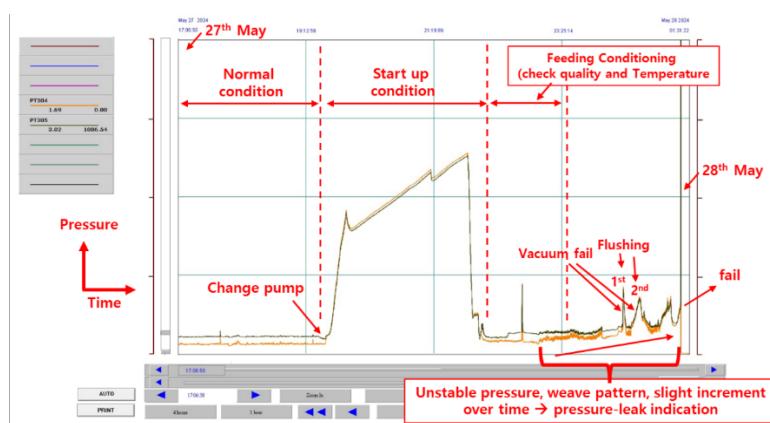
Based on the visual investigation of the failures mentioned earlier in the connection vacuum chamber between the ice-condenser and deodorizer, three specific locations were identified where the failures occurred. These locations include the expansion structures, the welded joint at the curved region of the horizontal vacuum chamber, and the welded joint at the vertical vacuum chamber. Hence, conducting an in-depth investigation into the prior activities leading up to the accident is crucial in order to comprehend what happened before the occurrence of the failures. Figure 5. displays the monitoring of pressure levels a few hours before to the failure, together with the corresponding condition state within a certain time period. Starting from the evening of May 27th, the pressure level remained at a normal condition. Furthermore, there was an action taken to replace the pump at around 19:00. Subsequently, the refinery is brought to the initial operating state by gradually reducing the pressure level until it reaches a vacuum condition. After determining the operational pressure level range, the feeding condition commenced at around 22:00. Unfortunately, a deviation in the monitoring of pressure levels was detected at around 23:00. The pressure level exhibited a consistent change with a progressive increase. The flushing is a corrective treatment performed by operators to regulate the pressure level and return it to the acceptable range for operational conditions. According to the findings from monitoring the pressure levels, there is a significant possibility of indicating leakage before failures occur.

**Figure 5.**  
Pressure Level Monitoring

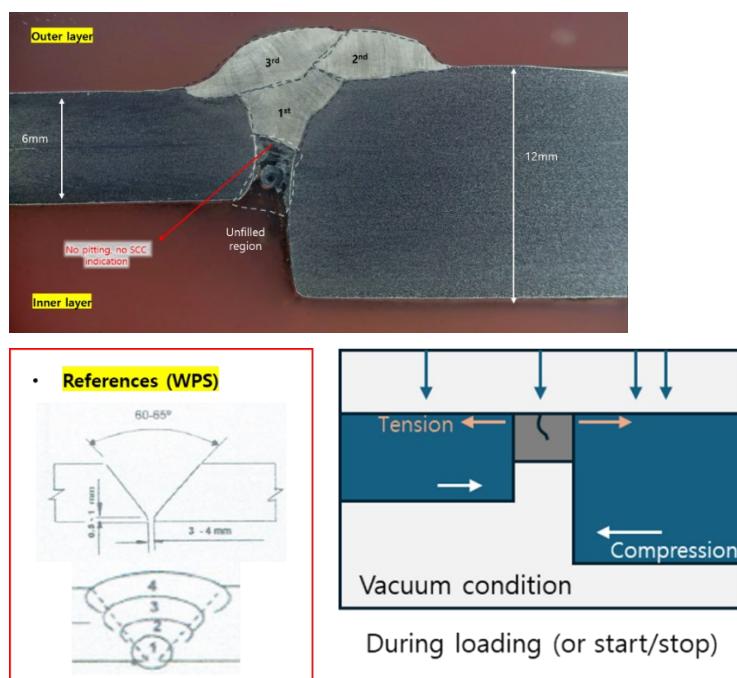
To verify the incomplete joint penetration examination on failure area specifically at welding, a microstructural observation has been conducted on the 12 mm/6 mm welded joints. Figure 6 displays the cross-sectional picture of the welded joints that were chosen from the vertical vacuum chamber. The incomplete joint penetration is readily evident and confirms the findings of the visual investigation results during the visit. It is important to note that the weld zone, also known as the fusion zone, is free from any flaws such as porosity, slag inclusion, or any other imperfections. Furthermore, there is no visible trace of the fracture that forms within the heat affected zone (HAZ). Considering the given information, the welding process exhibited satisfactory performance overall, with the exception of inadequate penetration of the welding joint. While the stainless-steel material employed in this vacuum chamber from the condenser to the deodorizer tray is typically resistant to corrosion and still has possibility to be attacked by corrosion, the cross-sectional picture does not show any signs of susceptibility to corrosion. The absence of any pitting on both the welding root and the surfaces of the stainless-steel plates indicates these conditions as shown in Figure 6.

**Figure 6.**  
Cross-Section Image of the Welded Joints

The WPS document states that the welded joint design should be produced using a single-V groove. Regrettably, the cross-sectional image provided indicates that the single-V groove was not adequately prepared prior to the welding procedure. The incomplete joint penetration, as indicated by visual investigation and microstructure observations, suggests that this region may serve as a vulnerable point for stress concentration or potential failure in the overall structure of the condenser-to-deodorizer vacuum chamber. The tension and compression stresses would readily accumulate at the vulnerable point, as seen in Figure 6, during the whole process of production (i.e., mechanical and thermal expansion). Furthermore, it is anticipated that the cracks would

persist in this area for an extended duration. As the crack extended and the area decreased ( $P=F/A$ ), the stress exceeded the strength of the weak point, leading to eventual fracture. Furthermore, the pressure level monitoring detected a leakage signal around one hour before to the ultimate fracture. This proved that the crack had already caused a leakage in the weak spot structure. Within one hour, the weak spot was no longer able to withstand the load.

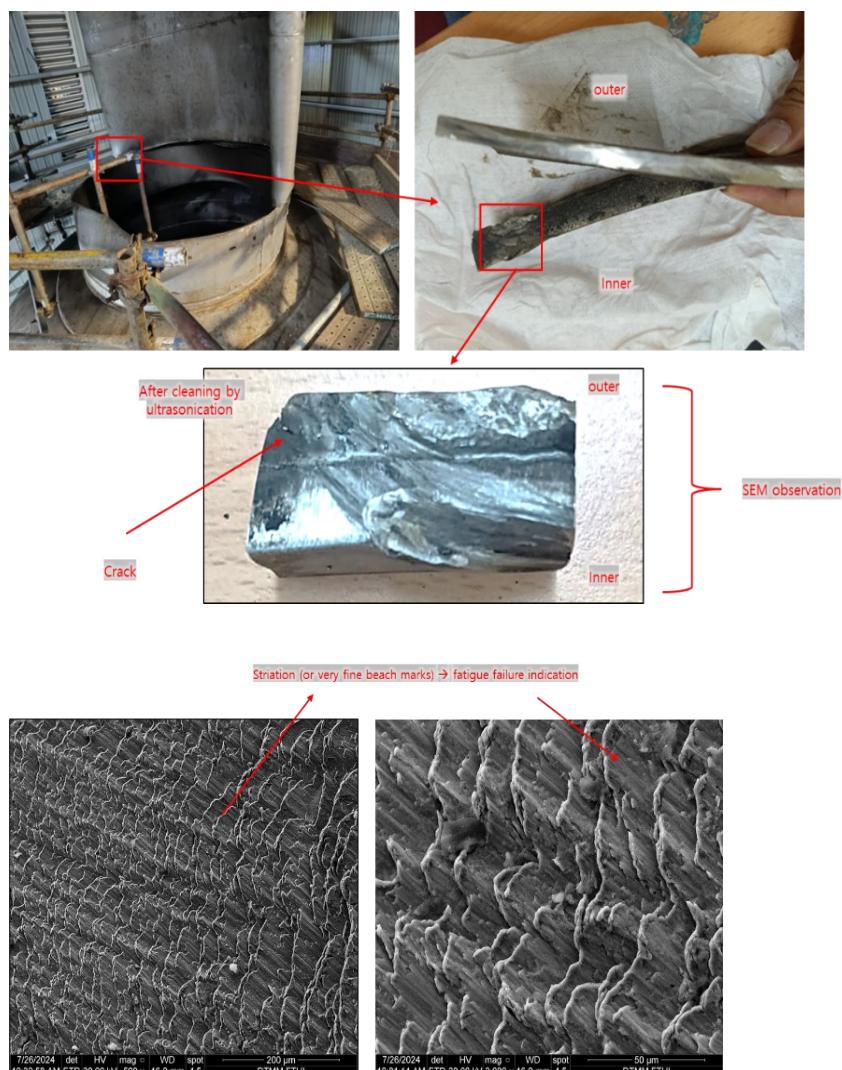
Fracture mechanics were used to investigate the fatigue strength of stainless-steel welded joints (Yang Peng, Jie Chen, Jun Dong., 2019), (Razmjoo, G.R., 1995). The observations of the fracture surface may be categorized into two regions: one from the expansion structures and the other from the welded joints. Figure 7. displays the fracture surface of the welded joints that were welded on-site within the vertical vacuum chamber. As expected, the fracture has indeed manifested on the surface of the weld zone, namely at this weak spot. When employing scanning electron microscopy (SEM) at a greater magnification, beach marks have been detected on the fracture surface. According to this evidence, it has been verified that there was fatigue stress cycle present in these welded joints.

**Figure 7.**  
Fracture Surface of the Welded Joints within the Vertical Vacuum Chamber

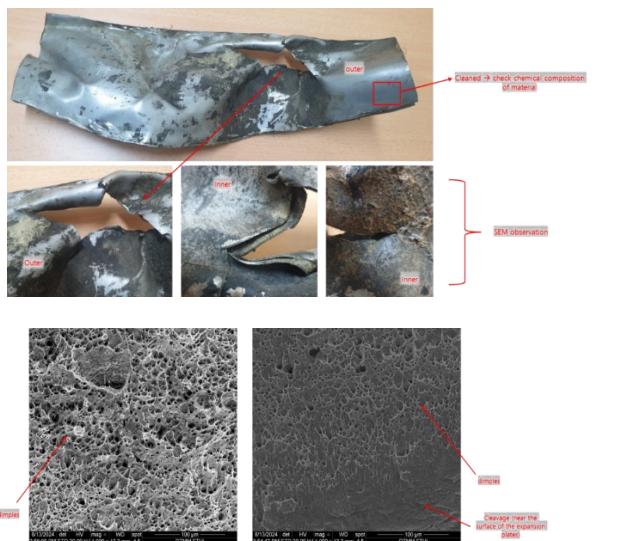
On the other hand, Figure 8 displays the fracture surface on the expansion structures. According to the scanning electron microscope (SEM) picture, the fracture surface does not exhibit any beach mark pattern. It suggests that the failure of these expansion structures was not caused by fatigue stress cycle. The presence of dimple patterns on the fracture surface suggests that plastic deformation occurred prior to the failure of these expansion structures. This indicates that the failures in these expansion structures occurred solely under situations of excessive stress or as a consequence of the first failure (i.e. after effect).

**Figure 8.**  
Fracture Surface of the Welded Joints Expansion Structures
